Seismic Isolation Architecture at the Tzu Chi Hospital Receives International Recognition

The First Seismic Isolation Building in Taiwan, Thoroughly Bound to a Singular Compassionate Mind

Seismic Isolation Pad the Key Player, Shock Absorbing Measure Far Exceeding Standard

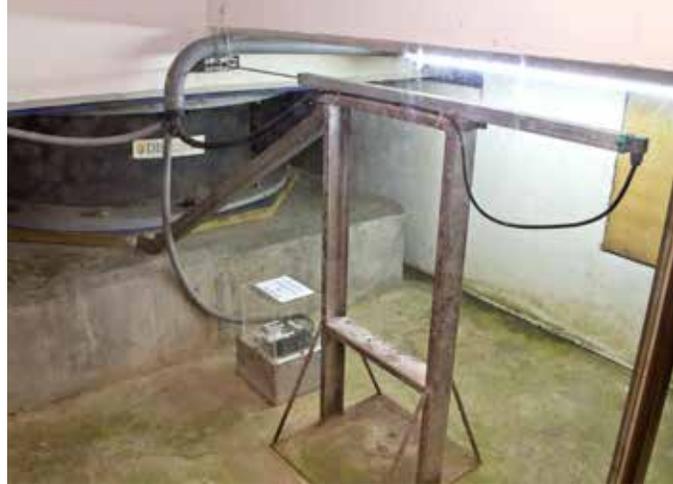
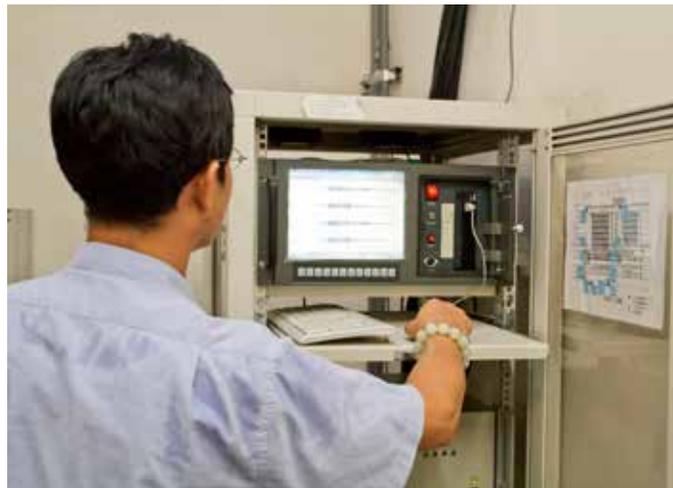
In the Unity Building of Hualien Tzu Chi Hospital equipped with seismometers in the underground, middle level, and roof top respectively. Photo depicts a seismometer located in the second basement floor.

in Taiwan that houses a seismograph. Should an earthquake take place, information like severity, horizontal shift amount, structural impact, and so forth will be directly transmitted to the Central Meteorology Bureau and the National Earthquake Center. Consistency between the originally implemented quake protection designs and the actual seismic events would then be verified.

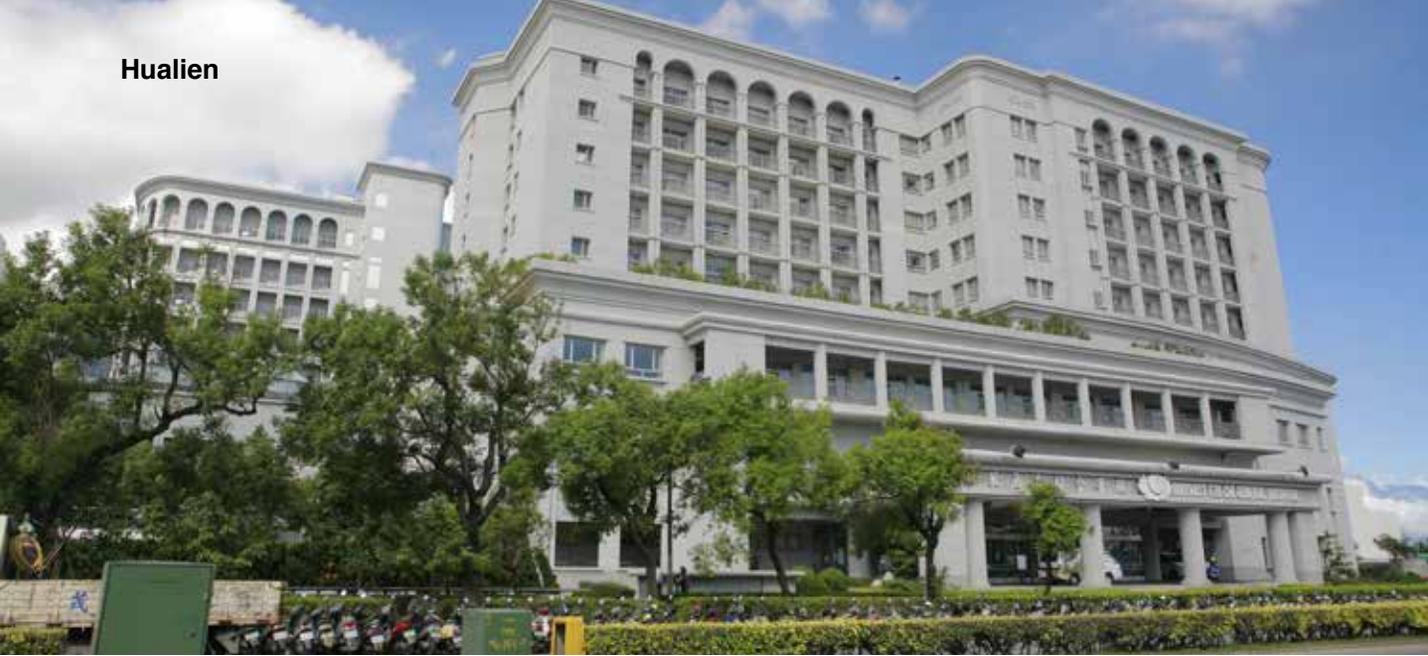
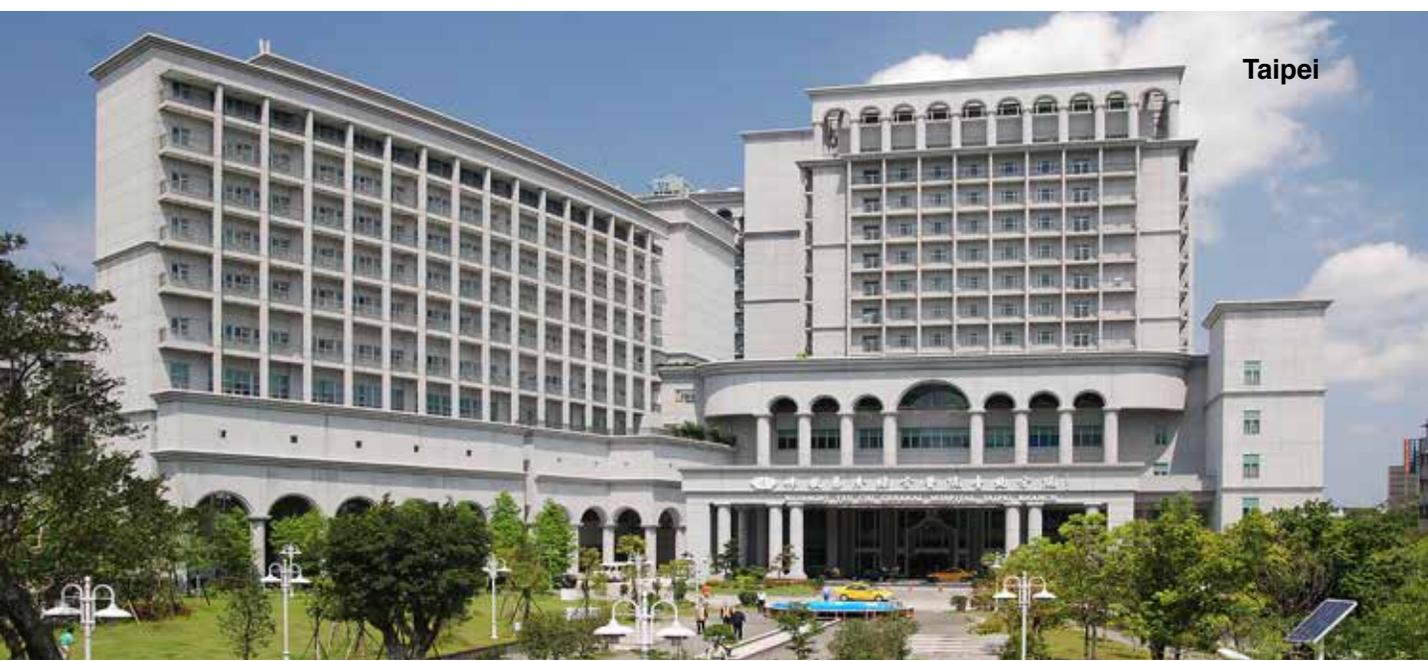
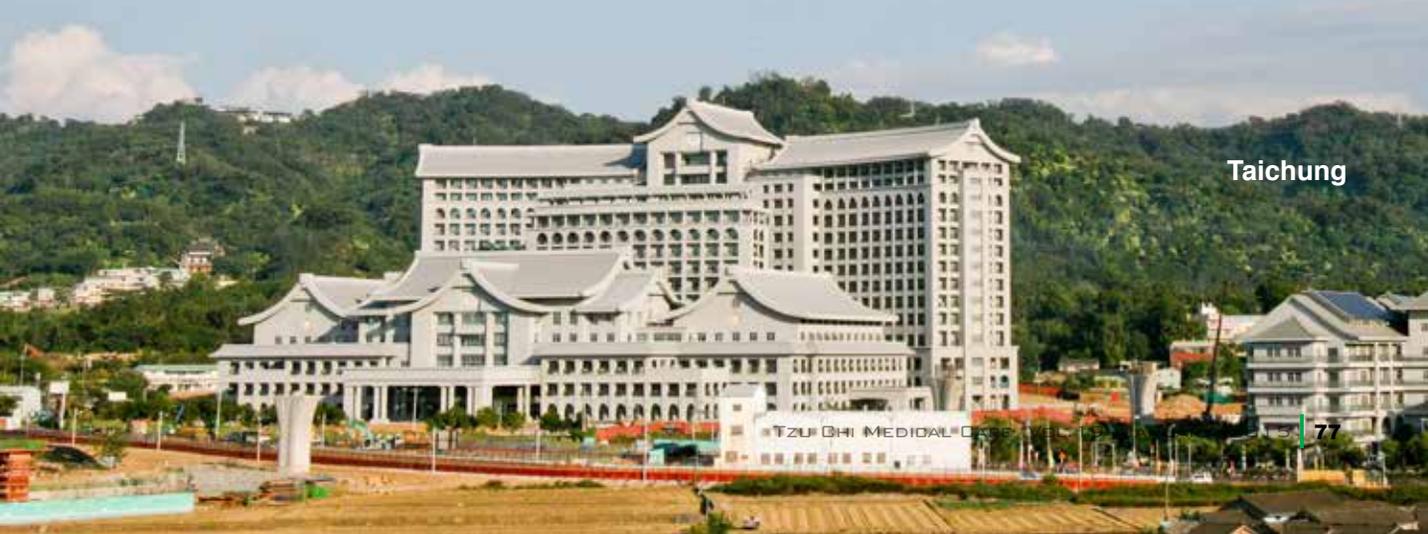
Tzu Chi Medical Mission starts the earthquake proof building. Taipei Tzu Chi Hospital is the first being built quake-proof building. The Unity Building of Hualien Tzu Chi Hospital is the first completed and commenced quake-proof building. Taichung Tzu Chi Hospital establishments are the largest scale quake-proof building then in the world.

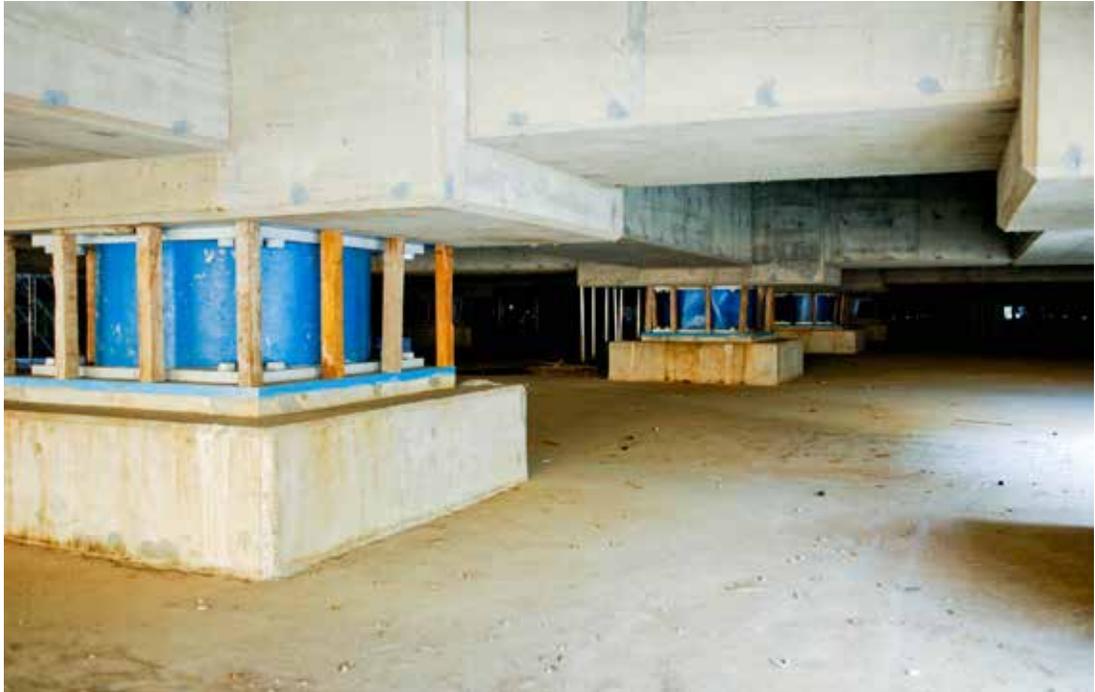
The seismic isolation pads could absorb 50~60% energy caused by an earthquake. Photo Depicts the pads set in the Taichung Tzu Chi Hospital establishment.

The key player in seismic isolating architecture is the Seismic Isolation Pad, which shoulders the critical responsibility of protecting the building and dissipating earthquake energy. It is endearing nicknamed “the Vajra Throne” by Tzu Chi members. The Unity Building on the Hualian Tzu Chi Hospital campus has 88 of these installed, while the Taipei Tzu Chi Hospital has 349 in place. However, the Taichung Tzu Chi Hospital leads the pack with 455 deployed, making it the largest earthquake-protected medical facility in the world. Presently, it is the hospital that has the most seismic isolation pads installed.

Seismic Isolation Pad is a cushion woven from rubber. It consists of an approximately three millimeter thick layer of rubber pad intersecting with a millimeter thick layer of steel board. The exact assembly, diameter, and span of

absorbed solely by the structural frame of the buildings, which more easily incurs dangerous damages. Because seismic isolation pad can ensure balanced horizontal movement, when the earthquake hits, the leveled force rides upon the movement of the seismic isolation pad to exercise and dissipate the energy. Approximately 50 to 60 percent of the earthquake force are exercised and eliminated through the seismic isolation pad, while the remaining portions are endured by the architecture.

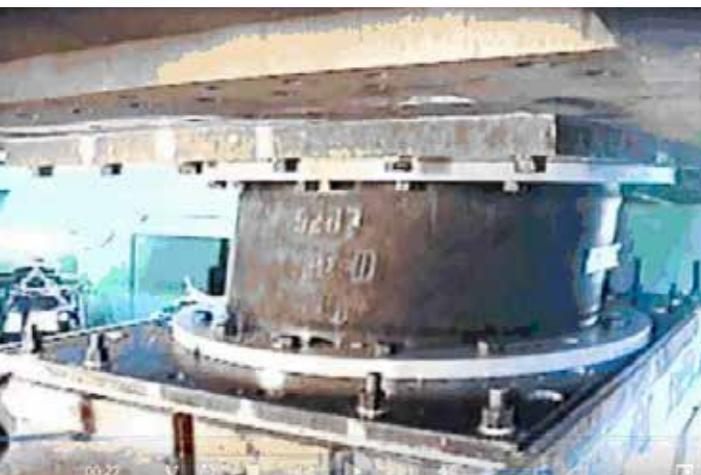
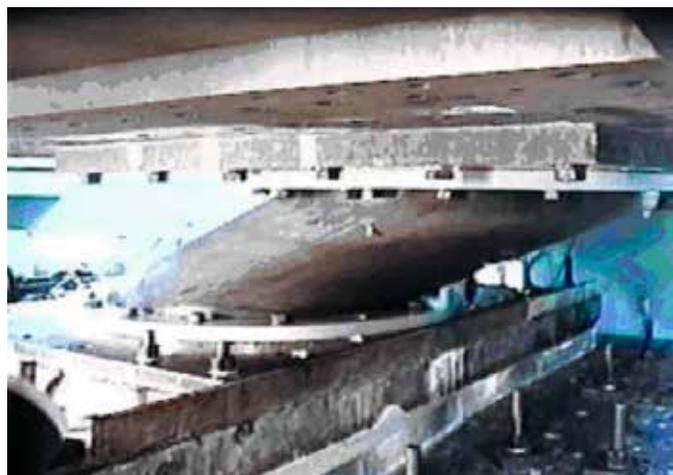
Tzu Chi Foundation invited the Dynamic Isolation Systems to test the pads. The pads could endure horizontal shifts by 60 cm intervals.

Because the seismic isolation pads designed for the Tzu Chi hospitals are enormous in size, with diameters exceeding one meter, in order to ensure the quality of the American seismic pad manufacturers, the Construction Division calculated that during major earthquakes, the pads should only levelly move left and right by sixty centimeters, which

when added to the eighty centimeters of seismic isolation joint, provides a space of 120 centimeter for level movement. These measurements exceed original design specifications and should make certain hazard free movement.

Chao-Min Lin states, usually design specifications are set at twice the required tolerance value. However, in making sure that that the deformation of seismic isolation pad does not pose a problem, Tzu Chi required that these seismic isolation pads be able to endure a 40 percent deformation by shearing force, which amounts to a four factor improvement upon the original design specifications. For example, if the actual event value is 1, then the design specification usually would be 2, but the Tzu Chi implementation is actually 4. Chao-Min Lin commented with pride, "We are the only one in the world to achieve this."

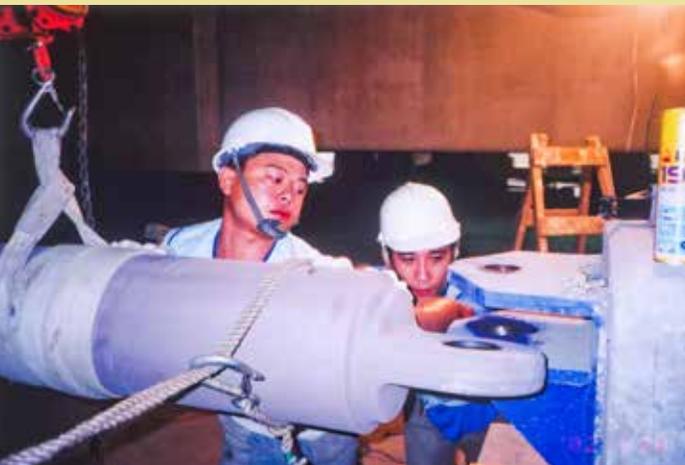
A worker moves a 1.84-ton damper targeting to its lock.

Besides seismic isolation pads, the quake isolation measures employed by Tzu Chi also includes Ground Dampers. The damper is a sort of level, hydraulic lever. During first moments of an earthquake, buildings take on very severe impacts from the quake force.

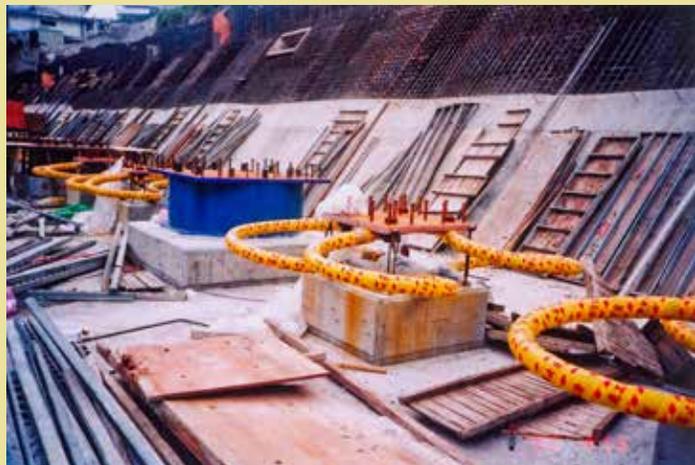
One steel ring damper of 600 kg is a key element for quake-proof in a randomly-shaped building.

For typical rectangular shaped building, the speed of shift would be controlled by the ground dampers. Also, there is a kind of steel ring ground damper that is shaped like a butterfly, which is used with non-rectangular buildings. Taking the Taipei Tzu Chi hospital as example, its shape is not exactly rectangular. Rather, this structure consists of arc, square, and rectangular sections. When an earthquake strikes, the arc area of a building would likely take on whipping motion from extreme fishtailing. The steel ring ground damper is precisely for reducing the severity of the whipping motion.

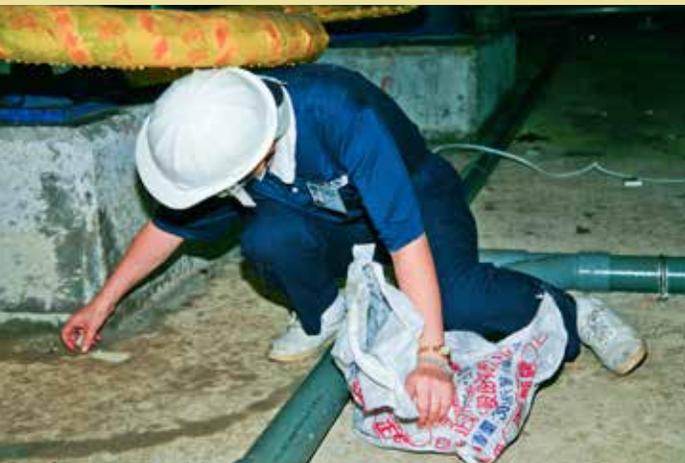
One Tzu Chi volunteer cleans in the isolation pads area during Taipei Tzu Chi Hospital's construction period.

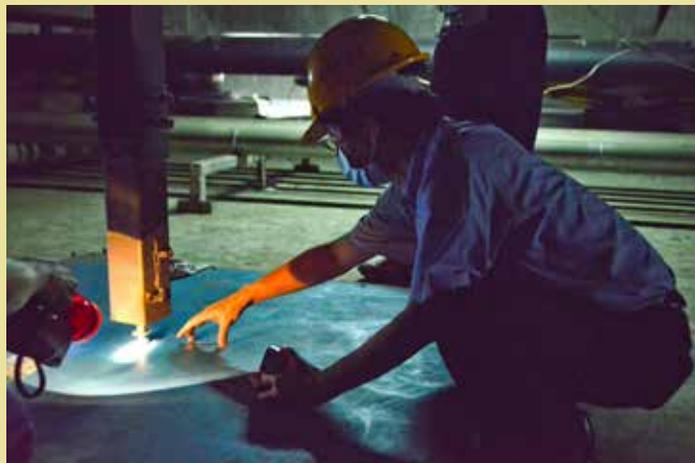
With the hospital situated at a location of frequent earthquake occurrences, the installed movement gauges all returning to original state and the seismic isolation system was well maintained. It delivered good quality isolation.

To assess whether the seismic isolation system fully served their function, at the center point of the seismic isolation level within the building, also referred to as the position of the “geometric planet”, a movement gauge is installed. After an earthquake, one only needs to check whether the gauge has returned to its original center axis. If it did not return, then there should be some remaining stress in the seismic isolation pads that has yet to be released.

sent engineers to inspect the state of products that have been in use for nearly a decade at the Tzu Chi Taipei Hospital. With the hospital situated at a geographic location of frequent earthquake occurrences, the installed movement gauges all returning to original state, and the underground seismic isolation system was well maintained and delivered good quality isolation. The inspectors were 100% satisfied.
